US16 Corridor Study Crash **History Review** (2014 — 2018) US16 Corridor Study

Pennington County, SD August 6, 2019

This memorandum documents the 2014 through 2018 crash history analysis for the US16 corridor between the Keystone Wye (south end) and Cathedral Drive/Fairmont Boulevard (north end). The crash history analysis was conducted to help identify areas that may warrant consideration of safety-related improvements in future design.

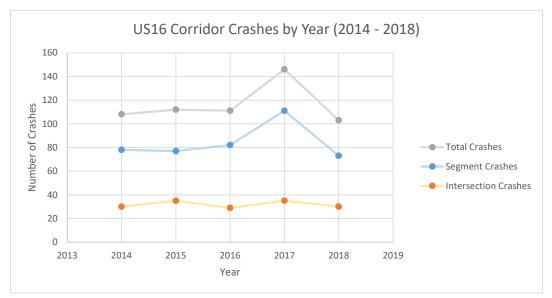
Figure 1: US16 Corridor – Crashes by Year (2014 - 2018)

Crashes sorted by year and whether they occurred on a US16 corridor segment or at a US16 intersection are summarized in **Figure 1**. There was a spike in segment crashes in 2017 compared to the other five years. Further review indicated that there were 85 vehicle-animal crashes in 2017. This represents over 30 percent of the 5-year vehicle-animal crash total.

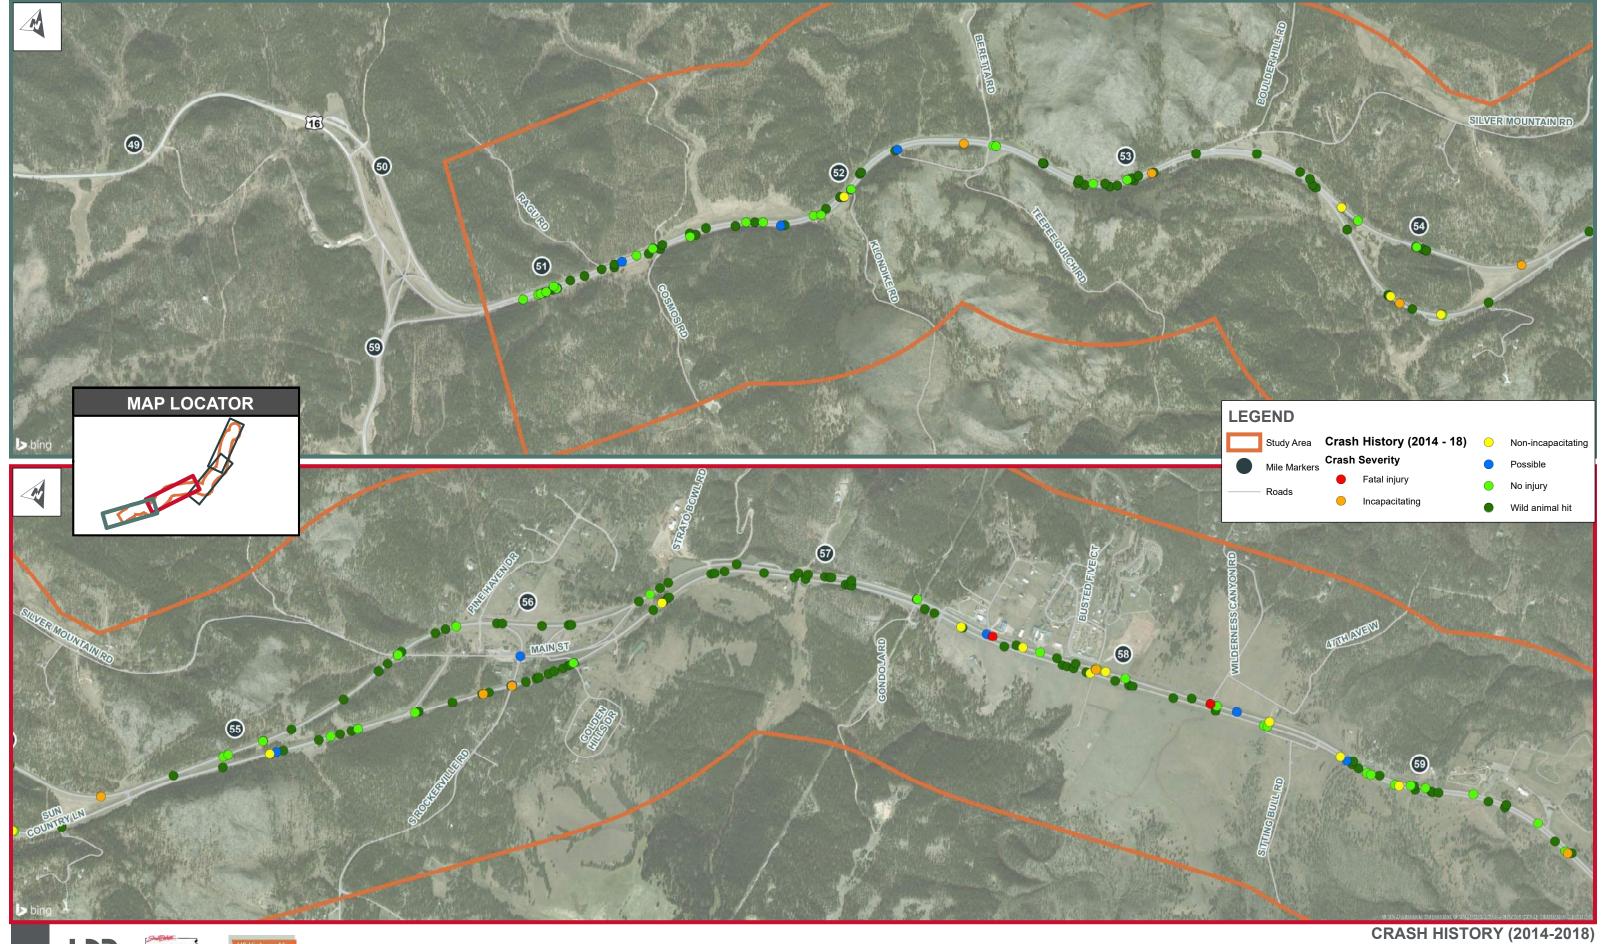
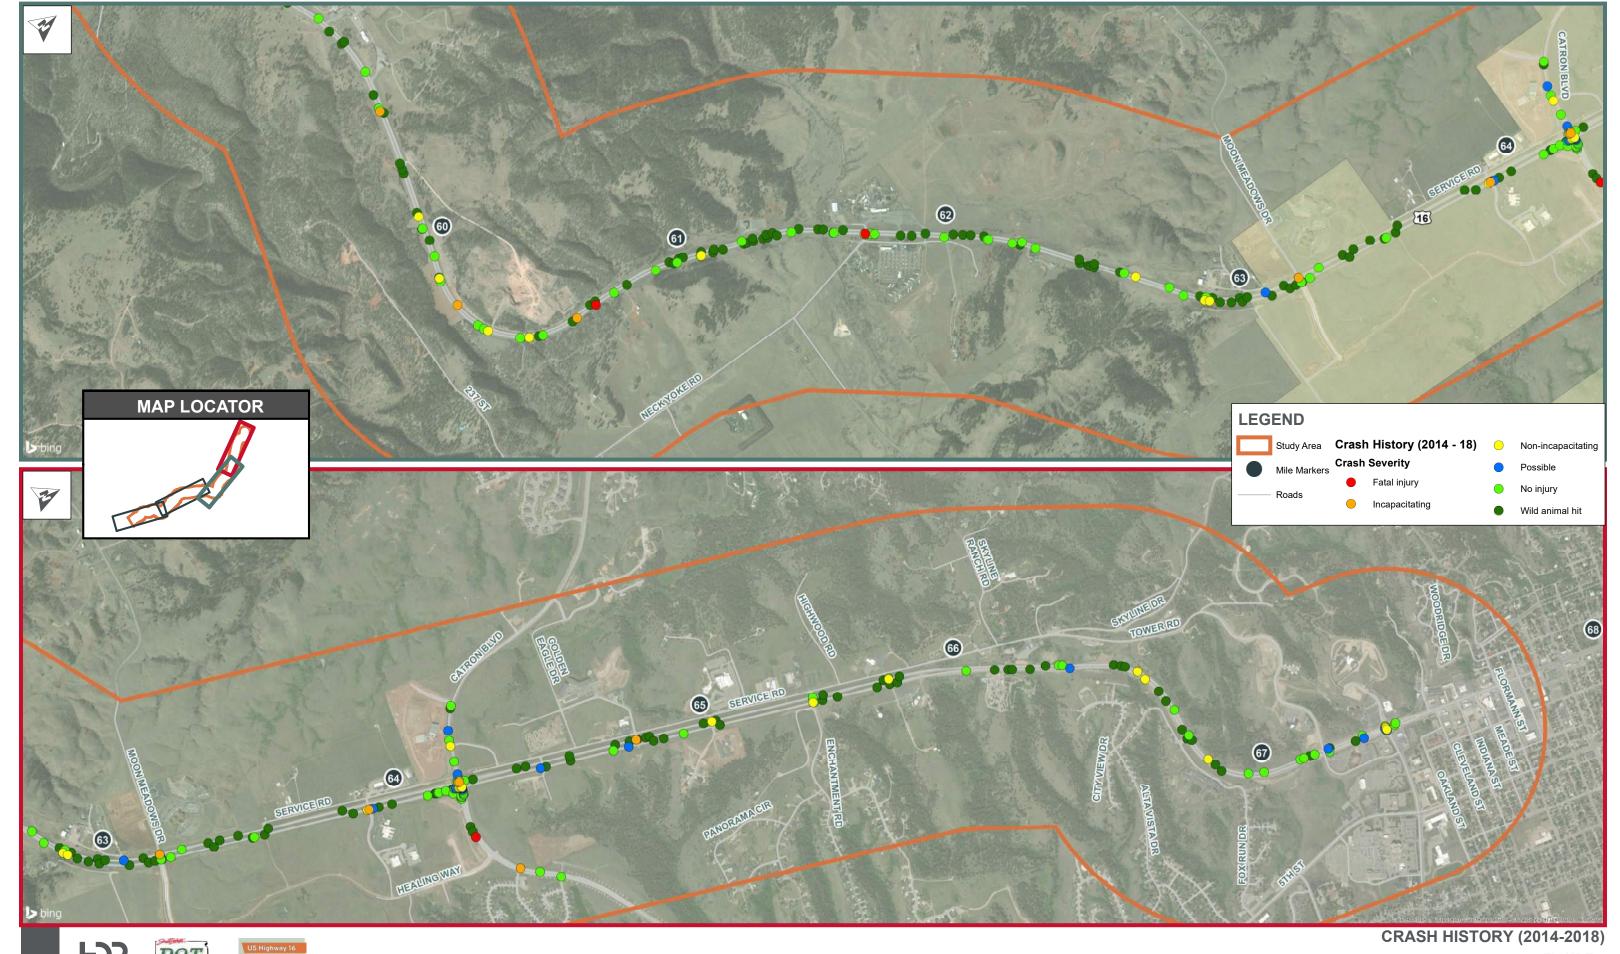
FIGURE 2

Of the 580 crashes, four resulted in a fatality and 120 resulted in an injury. Crashes sorted by 'fatal', 'injury', and 'no injury' (property damage only, or PDO) are summarized in **Table 1** presented spatially in **Figure 2**.

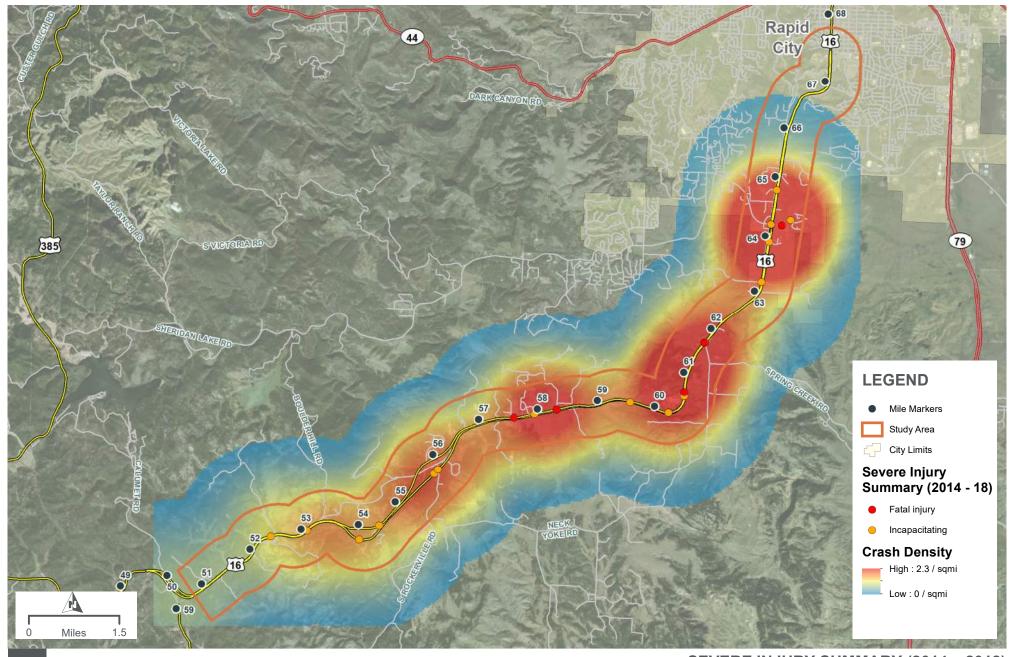
SEVERE INJURY SUMMARY (2014 – 2018)

There were four fatal crashes over the 5-year analysis period, two at intersections and two along roadway segments. There was a greater propensity for injury crashes at intersections, as approximately 43 percent of the intersection crashes resulted in injury or fatality, compared to 13.5 percent of the segment crashes resulting in injury. A summary of all fatal and incapacitating injury crashes are shown in **Figure 3**.

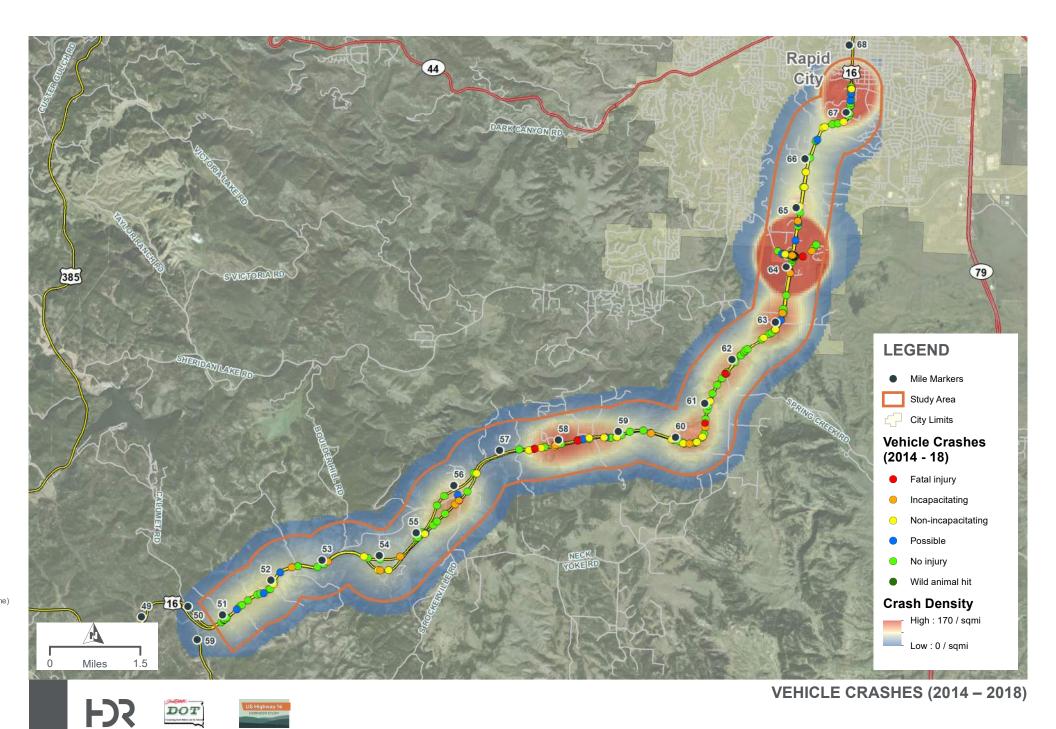
FIGURE 4

Maps representing crashes that did not involve (vehicle only crashes) and involve (vehicle-animal crashes) animals are provided in **Figure 4** and **Figure 5**, respectively.

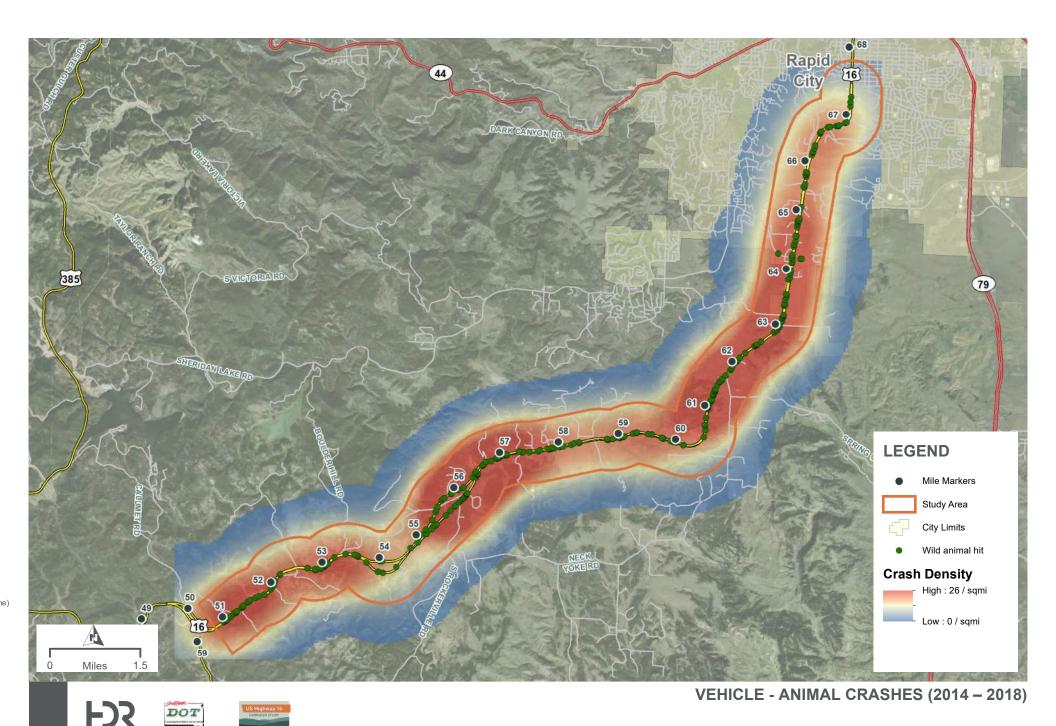
FIGURE 5

There is a high propensity for vehicle-animal crashes along this corridor, representing nearly half of all crashes along the study area corridor. For US16 corridor segments, vehicle-animal crashes represented over 65 percent of all segment-related crashes.

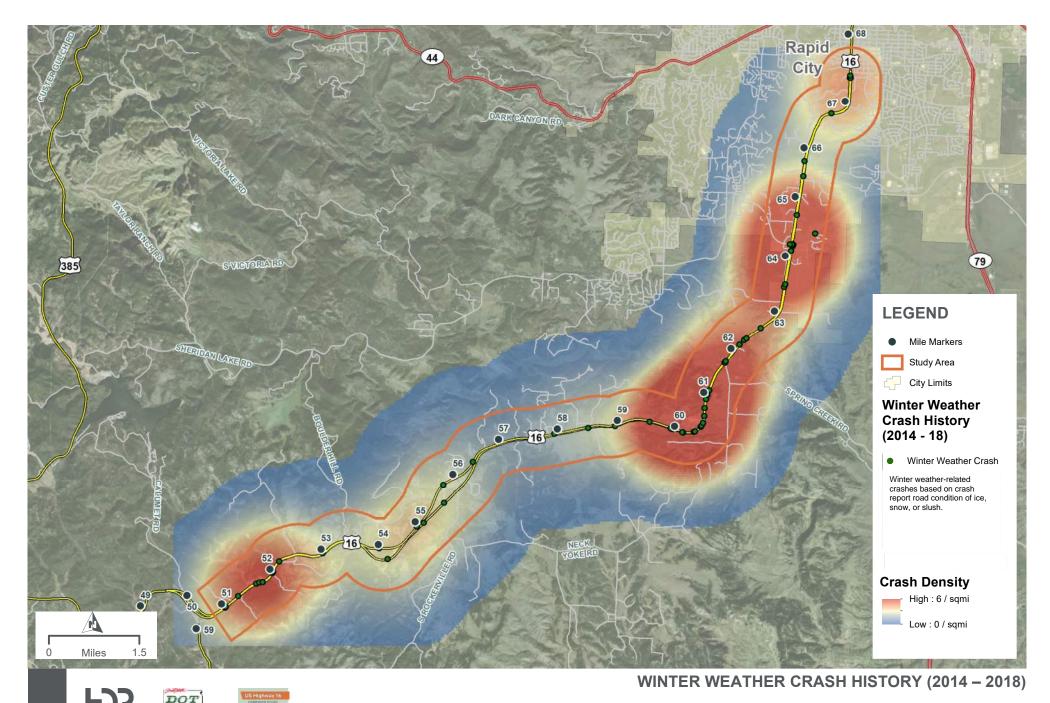
FIGURE 6

Winter weather-related crashes were also reviewed from a corridor perspective. **Figure 6** depicts all crashes where the crash report noted road condition of ice, snow, slush, or frost. In total, there were 68 winter weather-related crashes corridor-wide.

It can be concluded that from a corridor-wide perspective, winter weather and inclement travel conditions has an effect on safety through the corridor.

Review lighting warrants at unlit intersections that may experience higher turning demand during nighttime hours. Also, review winter weather/blowing snow locations for potential modifications to existing cross-sections, implementation of motorist information technologies for winter weather and fog conditions, and/or installation of snow fence.
